Northwest Sumatra and Offshore Islands Field Survey after the December 2004 Indian Ocean Tsunami

An International Tsunami Survey Team (ITST) conducted field surveys of tsunami effects on the west coast of northern and central Sumatra and offshore islands 3–4 months after the 26 December 2004 tsunami. The study sites spanned 800 km of coastline from Breuh Island north of Banda Aceh to the Batu Islands, and included 22 sites in Aceh province in Sumatra and on Simeulue Island, Nias Island, the Banyak Islands, and the Batu Islands. Tsunami runup, elevation, flow depth, inundation distance, sedimentary characteristics of deposits, near-shore bathymetry, and vertical land movement (subsidence and uplift) were studied. The maximum tsunami elevations were greater than 16 m, and the maximum tsunami flow depths were greater than 13 m at all sites studied along 135 km of coastline in northwestern Sumatra. Tsunami flow depths were as much as 10 m at 1,500 m inland. Extensive tsunami deposits, primarily composed of sand and typically 5–20 cm thick, were observed in northwestern Sumatra. [DOI: 10.1193/1.2207724]

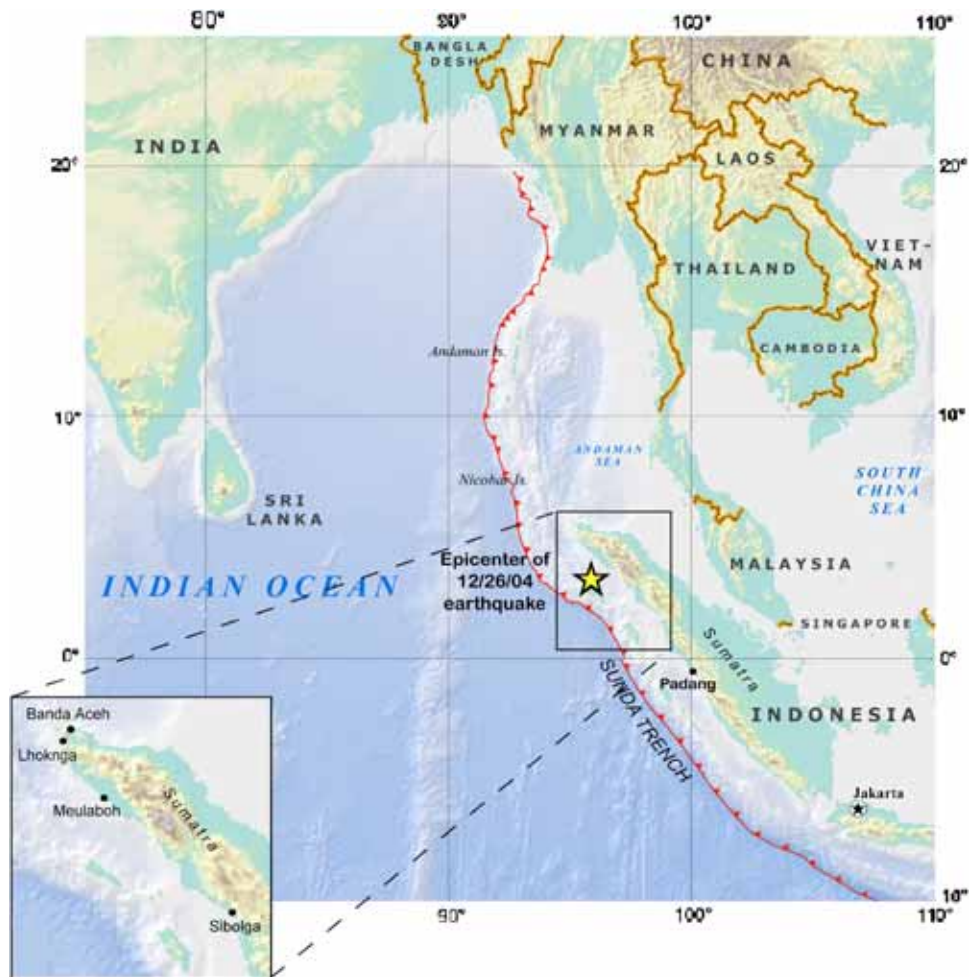
Figure 1. Survey area, showing the epicenter of the 26 December earthquake and the interplate thrust fault, indicated by the sawtoothed line. This figure was modified from a USGS poster, “Sumatra-Andaman Islands Earthquake of 26 December 2004—Magnitude 9.0,” which can be accessed at <http://neic.usgs.gov/neis/poster/2004/20041226.html>.

plate megathrust extending from offshore northern Sumatra to the Andaman Islands (Lay et al. 2005, USGS 2005, Stein and Okal 2005) (Figure 1). The earthquake occurred at 07:58 local time in Indonesia (00:58 UTC). The tsunami arrived in northern Sumatra, the hardest-hit region, within 15–20 minutes after the earthquake. Fatalities from the tsunami and earthquake in Indonesia totaled 128,645, with more than 37,063 persons missing and 532,898 persons displaced (USAID 2005). Virtually all of the loss of life and damage is attributable to the tsunami.

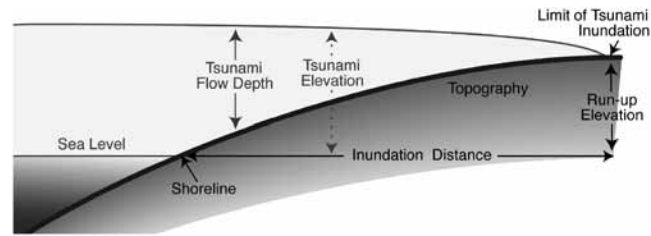
Figure 2. A tsunami inundating land, illustrating the terminology used in this paper.

The measured water levels included (1) runup elevation, which is the elevation at maximum inundation; (2) flow depth during the tsunami, which is the height of the tsunami above the ground; and (3) tsunami elevation, or the height above sea level, which is the sum of the flow depth and land elevation (Figure 2). The minimum flow depths during the tsunami were indicated by broken branches (Figure 3a) or stripped bark in trees, debris in trees, snapped trees, gouge marks in trees, impact marks on rock out-

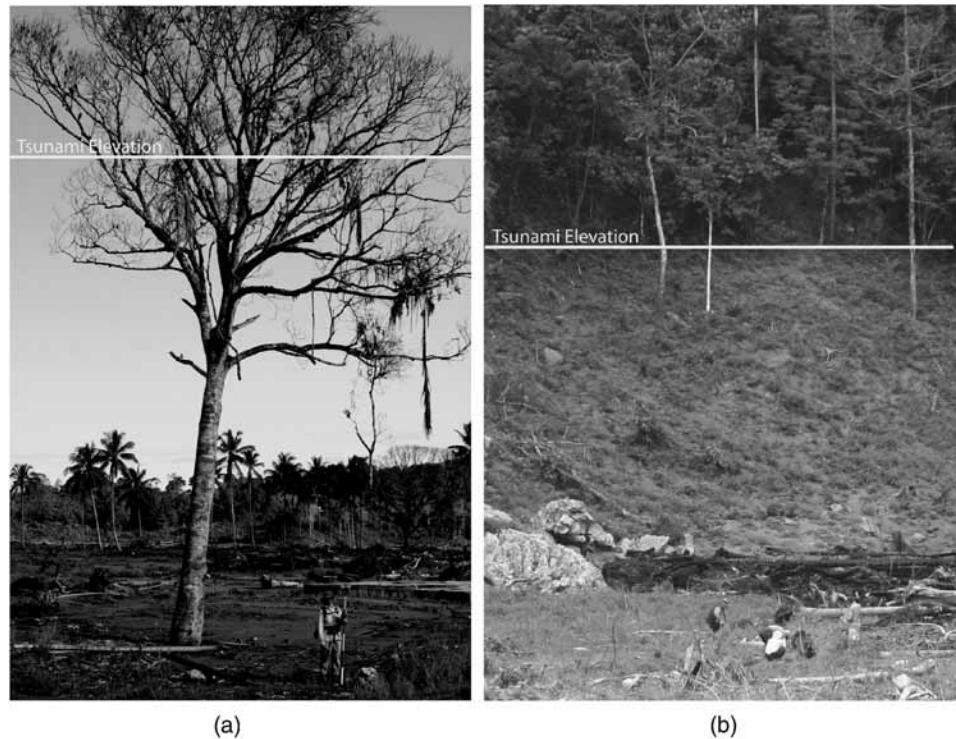
Figure 3. (a) Surveying the topographic profile in front of a large tree that survived the 26 December tsunami at Lhok Kruet, Sumatra. Note the branches high in the tree that were broken by the tsunami. The combination of broken branches and debris high in the tree, primarily palm fronds, indicate that the tsunami flow depth was 9.9 m at this location, which is approximately 275 m inland. (b) Trim line at Jantang at 19.7 m above sea level when the tsunami struck. Vegetation below the line was stripped by the tsunami and had begun to grow back. In the foreground, the team members examine a tsunami deposit (photos: B. Jaffe).

crops, and watermarks on buildings (rare along the sites on the west coast of Sumatra visited by this ITST, because nearly all the buildings were destroyed). Runup was indicated either by a wrack line of debris or a trim line, which is the level on a hill or cliff below which all vegetation was stripped by the tsunami (Figure 3b).

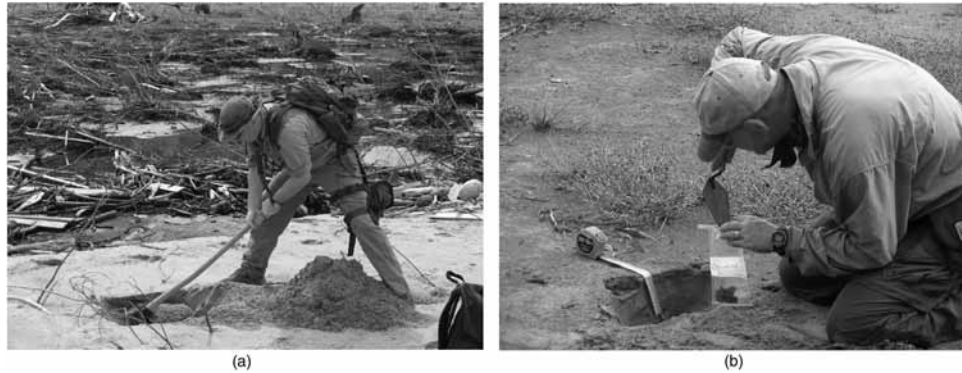
Figure 4. (a) Trenching at Jantang, Sumatra. This trench is in a berm that formed several months after the tsunami as the shoreline and the near-shore area adjusted to coseismic subsidence and erosion from the tsunami. The area landward of the trench was flooded because it had subsided during the 26 December earthquake (photo: A. Moore). (b) Collection of tsunami deposit samples for laboratory analyses of grain size (photo: B. Higman).

Tsunami deposits were examined in pits and trenches dug at intervals along a shore-normal transect and at selected off-transect locations (Figure 4a). The deposits were measured, photographed, and described in the field, and samples were taken for laboratory analyses. In the field, bulk samples of layers within the deposits were taken, and, at about a dozen locations, samples were taken at 0.5-cm or 1-cm intervals to document the fine-scale vertical variation of grain size in the deposit (Figure 4b). The goal of collecting these samples is to use them, in conjunction with field observations, photos, and peels, to develop relations between the tsunami flow and the deposit it leaves (e.g., the relations between flow speed and deposit characteristics).

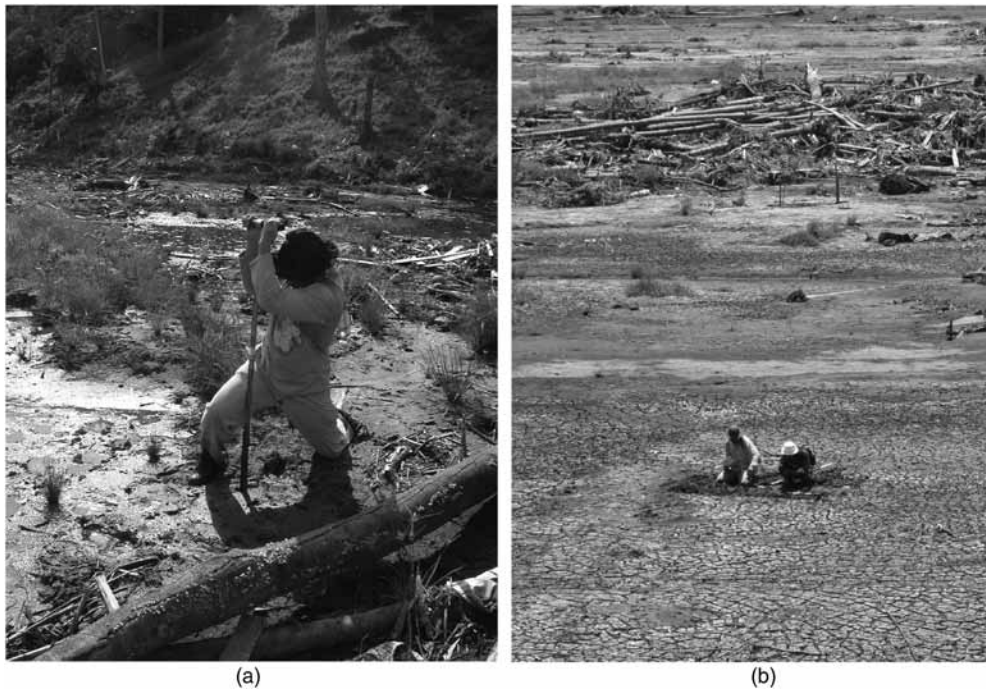
Figure 5. (a) Push coring in search of paleotsunami deposits at Jantang (photo: L. Dengler). (b) ITST members examining a trench in a tsunami deposit approximately 1 km inland at Kuala Meurisi, Sumatra. Note the laterally continuous nature of the deposit, water ponded in local topographic lows, and mud cracks at the surface of the deposit. The trees in the photo were ripped up from a seaward location and transported to this location by the 26 December tsunami. The trunks are oriented parallel to the tsunami flow direction (photo: B. Jaffe).

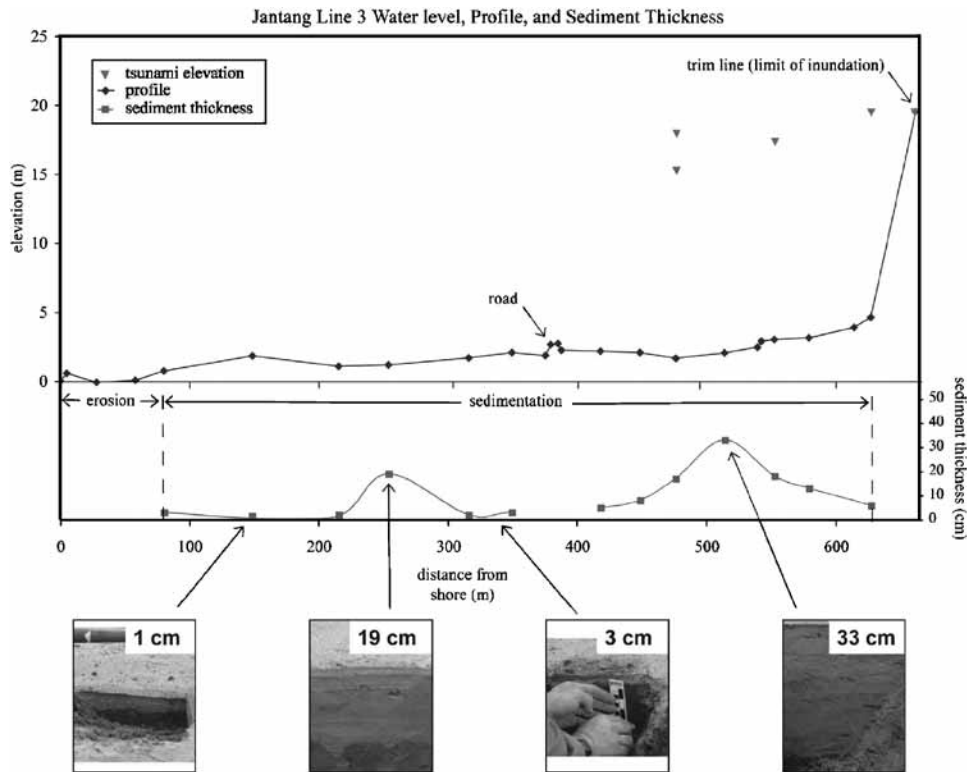
Figure 8. Topographic profile, tsunami deposit thickness, and tsunami flow depths and elevations at Jantang, Sumatra, on transect 3, which is the center transect in Figure 7. The maximum tsunami flow depth was 16.4 m at 476 m inland, and it decreased to 15.0 m at 628 m inland, which is 37 m seaward of the trim line. The tsunami elevations increased from 18.1 m to 19.7 m over this section of the transect. Note that there was an erosion zone seaward of the tsunami deposit and that the deposit thickness varied along the transect, appearing to respond to subtle changes in topographic slope.

Thicknesses of tsunami deposits were variable along transects (Figure 8) and from site to site (Appendix). At Kuala Meurisi, a section of coast with beach ridges, deposit thickness variation was large, with greater thickness in the swales. The maximum deposit thickness observed at any site was 70 cm, although typical thicknesses were 5–20 cm. The thickest deposits did not correlate with the deepest tsunami flow depths (e.g., Jantang, Figure 8). Deposits were usually composed of multiple layers; the total thickness may reflect deposition during multiple waves and/or during uprush and return flow.

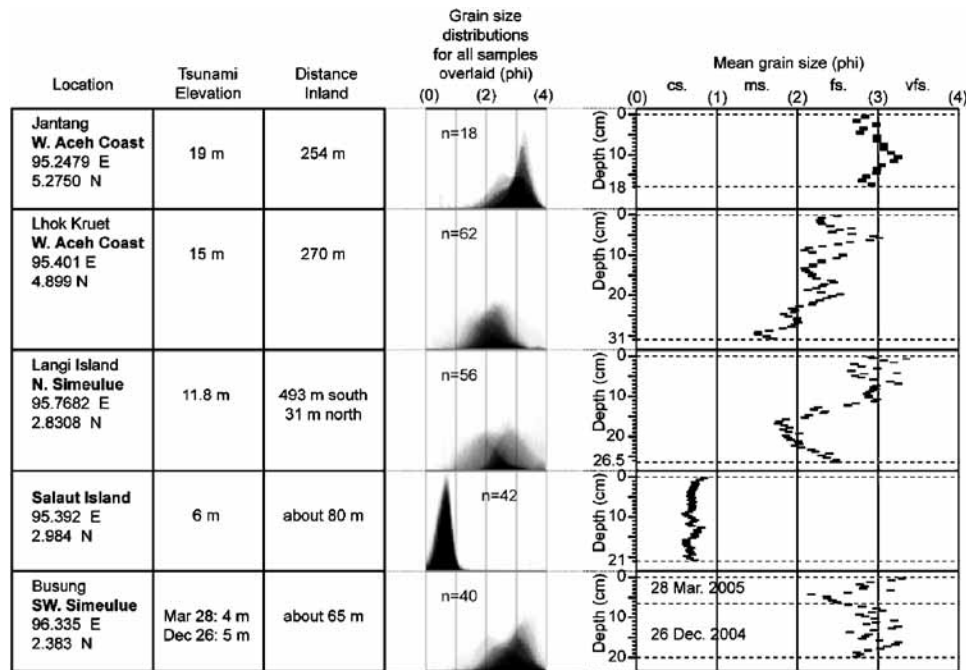
Figure 9. Vertical variation in the mean grain size of thick tsunami deposits created during the 26 December tsunami. At selected locations, we collected vertically contiguous sand samples from tsunami deposits for lab analysis. The grain sizes of each sample were determined by using settling velocity data from a 189-cm-long settling column. A composite distribution was plotted by binning grain size at 0.05-phi intervals and overlaying transparent histograms. The mean grain size is plotted against depth in the deposit where the vertical thickness of each rectangular mark is equal to the sample thickness (the scale at left), and the width of the mark is greater than the standard error of the estimate for mean grain size.

Both field observations and laboratory data documented normal and inverse grading, as well as massive sections in tsunami deposits (Figure 9). The causes for the observed variability in grading, which will be the topic of future papers, include differences in the processes of deposition (suspension versus bed load) and in the spatial and temporal gradients in transport.
